Deterioration and Maintenance of Pavements

Second edition

David Cudworth and Mujib Rahman

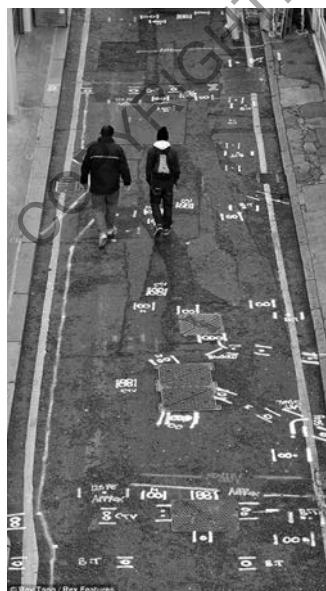
Figure 6.5 Underground utilities identified on a pavement surface

Pavements are often a conduit for utility apparatus, and this needs to be considered when planning intrusive surveys such as coring, trial pits or dynamic cone penetrometer (DCP) testing (Figure 6.5).

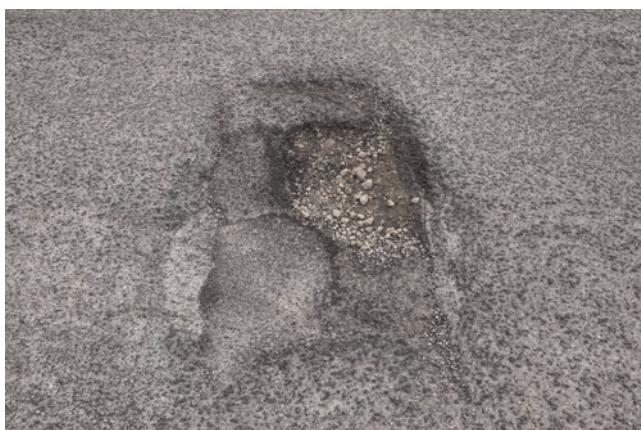
Figure 8.9 A pothole

The pothole shown in Figure 8.9 developed over a period of just a few days. At the time when the photograph was taken the location and depth of the pothole were sufficient for it to be considered a serious safety defect and an emergency repair was undertaken by the highway authority.

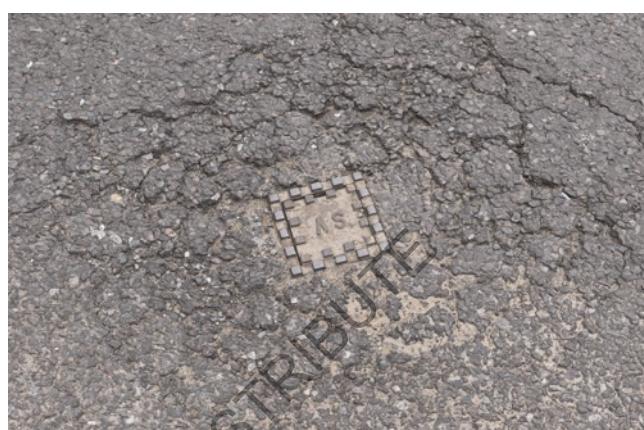
Figure 8.10 Pavement cracking around a small ironwork asset located within a carriageway

The area of cracking shown in Figure 8.10 is significantly larger than the area of the ironwork that has caused the cracking defect to occur. These defects are often caused by inadequate attention being paid to ironwork during maintenance (i.e. ironwork is not properly realigned to maintenance treatments with the differential in levels resulting in cracking).

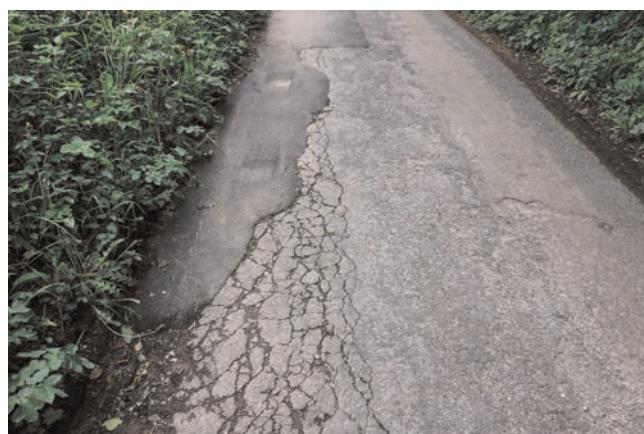
Figure 8.11 Serious edge deterioration at a rural location

The pavement shown in Figure 8.11 is a rural lane with poor lateral support and inadequate drainage. The photo also shows evidence of a previous patch repair, which indicates that this is likely to be an ongoing problem at this location. Recording the presence and condition of previous repairs can be useful in understanding the maintenance history of a pavement.
